Transformer Oil Leaks Repaired Without Draining Oil

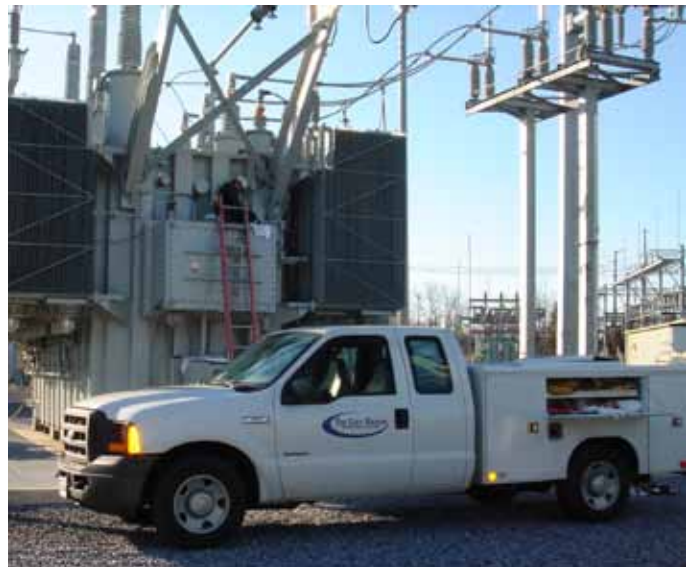
Today, these leaks can be repaired without draining or depressurizing the equipment by means of hydraulically injecting compatible sealants to stop the leak. The repair process varies depending on the type of leak, but a typical leak is found around the stem area of the radiator flapper valve. If the leak is located low enough on the transformer, the repair is completed with the unit in service, and in all cases the repairs are completed without draining the transformer.
